A Landslide Near Oslo, Minnesota

Roger C. Zejdlik

A Thesis
Presented to
the Faculty of the Department of Geology
University of North Dakota

by
Roger C. Zejdlik
January 1956

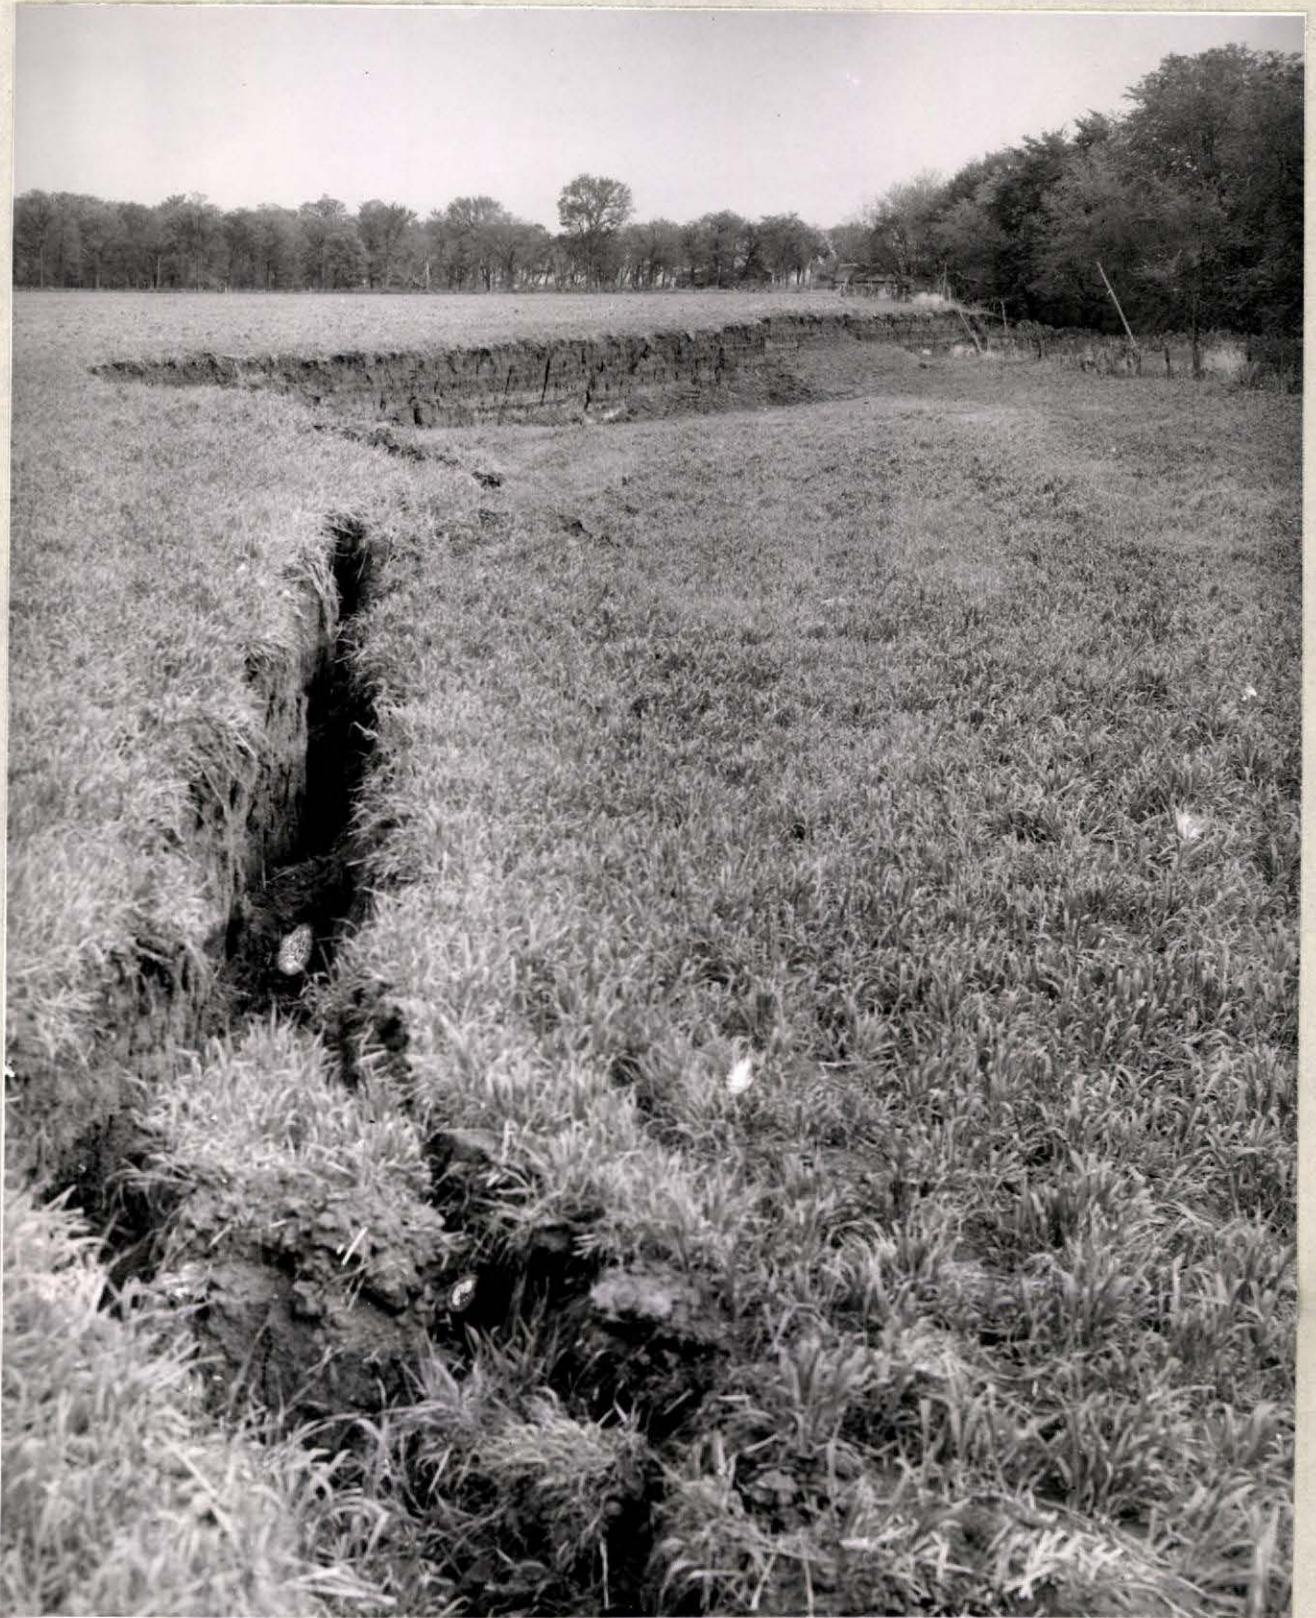
Figure 1. View looking southward along the break on the third terrace at the head of the slip. Note the very scabrous crescent-shaped fracture.

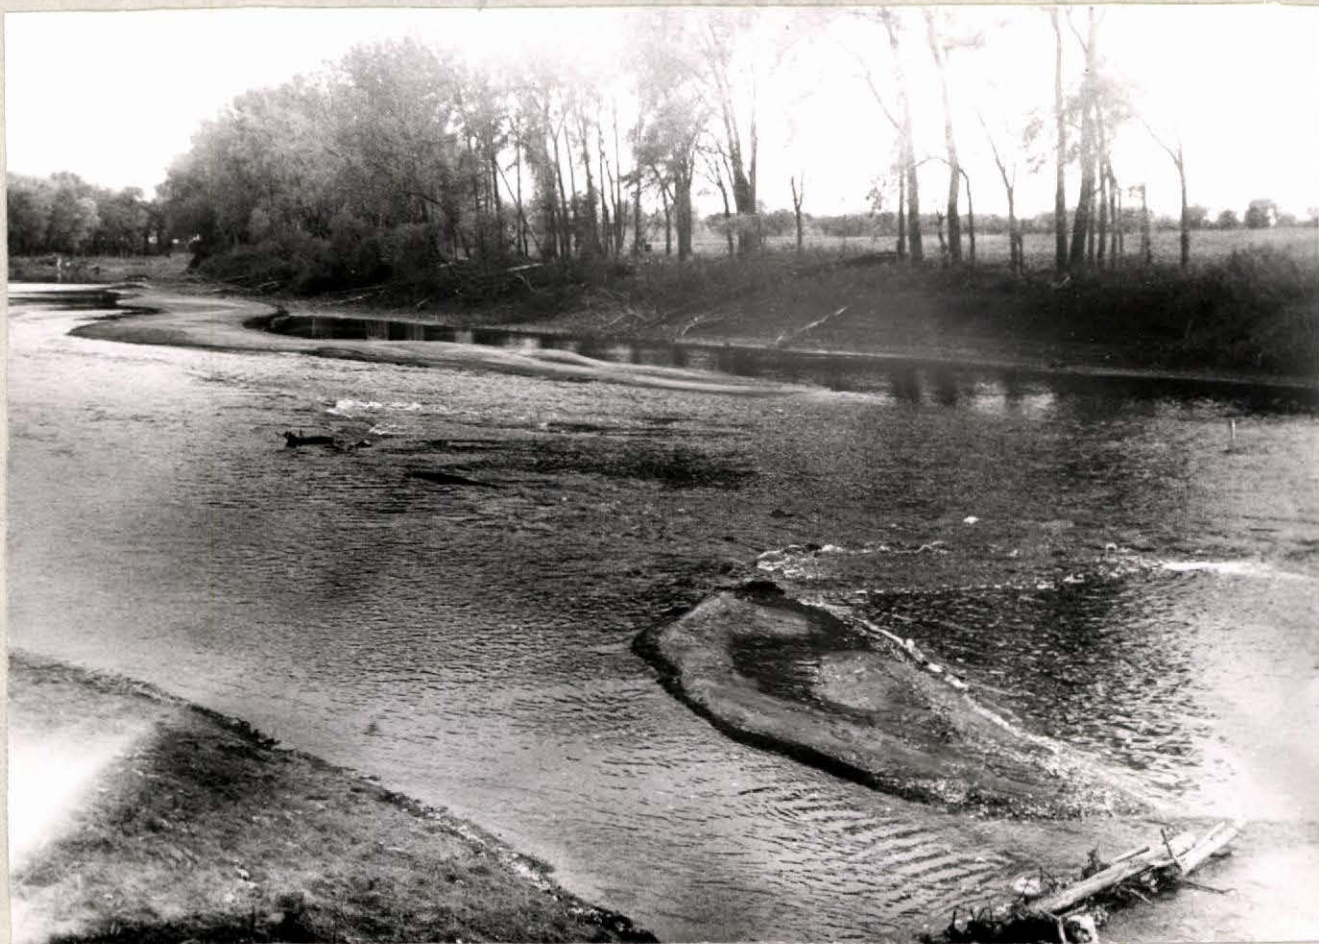
Figure 2. View looking southwest of the island running diagonally across the river. Note the rapids in the water, and also the main portion of the island on the slip-off slope of the river. Photo was taken standing at the north end of the island. Note the sharp bend in the river (upper left). It is not more than six feet deep across this portion of the river.

rushes through the narrow channel creating rapids which is a strange sight on the usually quiet Red River. The distance from the center of the fracture to the river is about 150 feet. This distance is the area covered by the higher flood of the Red River, however, for purposes of explanation, it will be divided into three step-like terraces. (see fig. 3). The first terrace consisting of the bottom of the river, the second terrace being a flat, brush, and tree-covered area running inland about 100 feet before rising sharply a distance of 15 feet to the third step-terrace. The fracture of the slide is 50 feet from the edge of the third terrace. Although only 50 feet of the surface actually dropped, the other 100 feet making up the second terrace remained in place. The only sign of sliding of the second terrace was the tilting of the trees away from the river and a slight back-drop. (see fig. 4).

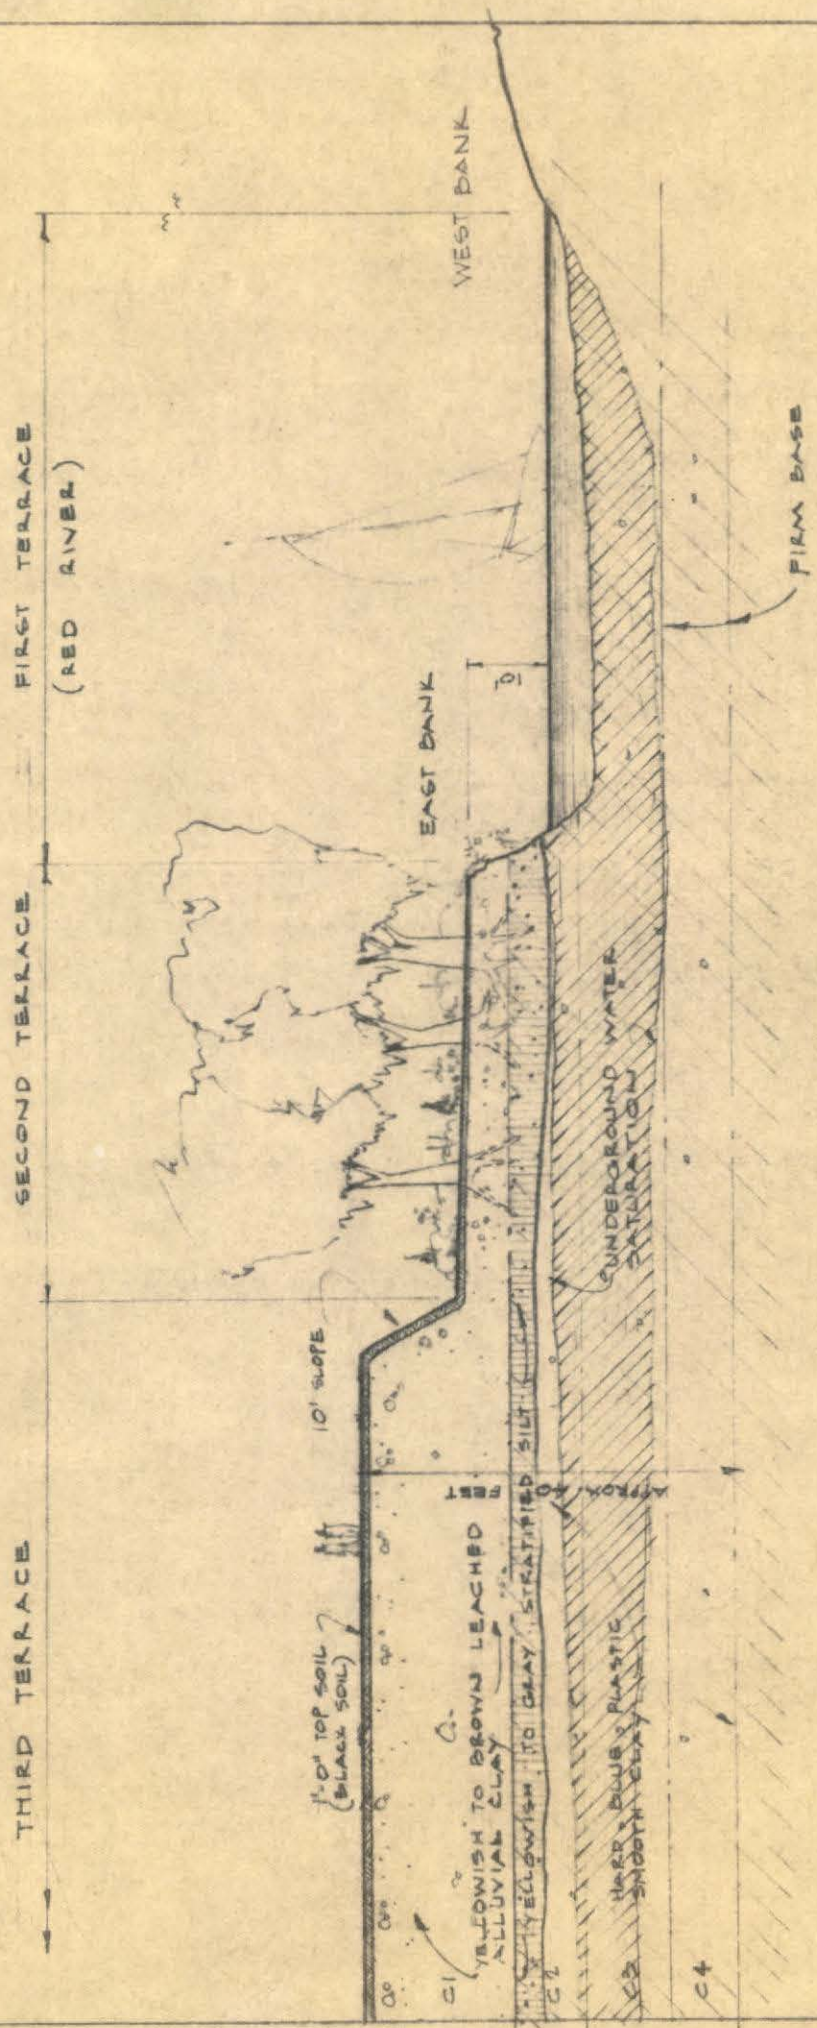
CROSS-SECTION PRIOR TO THE LANDSLIDE FIG. 3.

SOIL CONDITION PREVIOUS TO ACTION

AS THE EARTH FLOW MATERIAL WAS BEING COMPRESSED LATERALLY, IT WAS PROBABLY CHECKED BY THE RESISTANCE OF THE WEST BANK. DUE TO THE COMPACTION OF MATERIAL, THERE WAS BULGING THROUGH THE SOFTER RIVER MUDD.

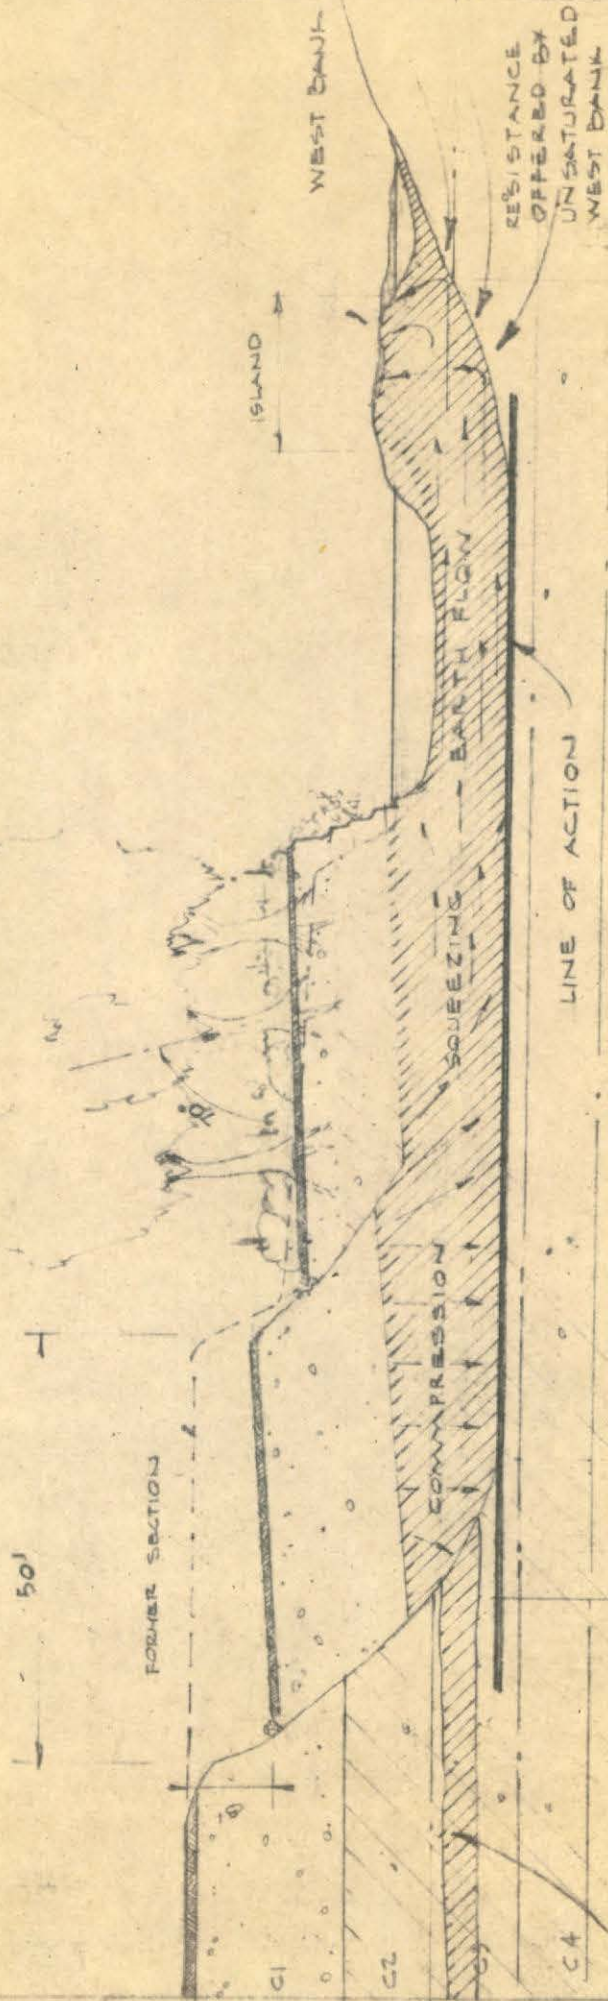
CROSS-SECTION AFTER THE SLIDE TOOK PLACE

LONGEST PART OF SURFACE SLIDING WILL TAKE PLACE IN SOFTEST STRATUM.

EARTH MOVEMENT BY LATERAL SPREADING
