Brine Spill Remediation: Crestwood Pipeline, McKenzie County, North Dakota

Tyson Jeannotte
B.S. in Environmental Geoscience
Senior Thesis

**BRINE SPILL REMEDIATION:
CRESTWOOD PIPELINE,
MCKENZIE COUNTY, NORTH
DAKOTA**

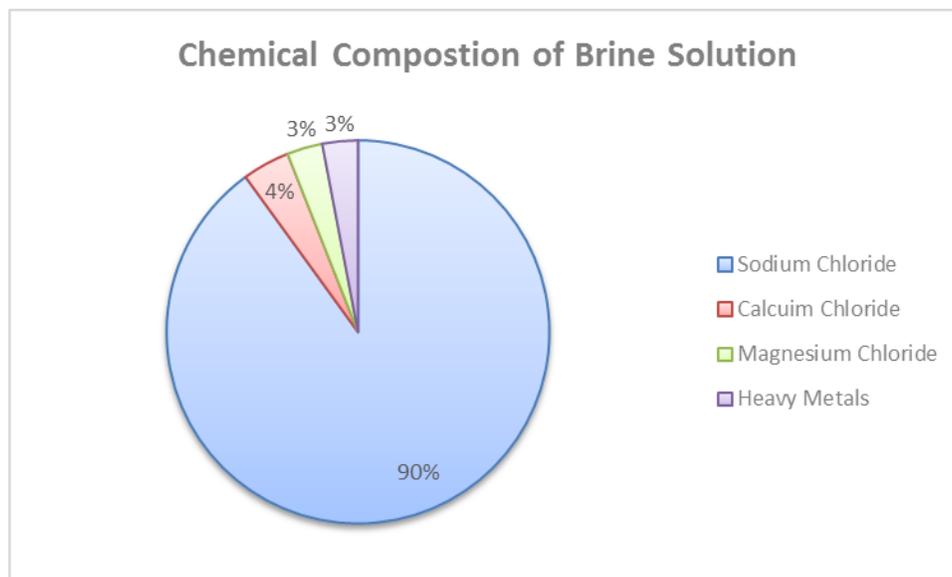
Figure 2. Chemical Composition of North Dakota Brine (Doll, 1989)

These brines are highly saline waters that come from the fracked shale rock formation of the Williston basin, thousands of feet below Earth's surface. The brine is five to eight times saltier than ocean water (Wood, 2014). North Dakota brine consists of 90% sodium chloride (NaCl) (see Figure 2). A thousand gallons of brine contains over a ton of NaCl (Doll, 1989). The other ten percent of the mixture consists of calcium chloride (CaCl₂), magnesium chloride (MgCl₂), and assorted heavy metals. These heavy metals consist of cobalt, nickel, copper, zinc, arsenic, selenium, silver, cadmium, antimony, mercury, thallium, and lead. Other dissolved substances include barium, and bromide (Song, 2014).

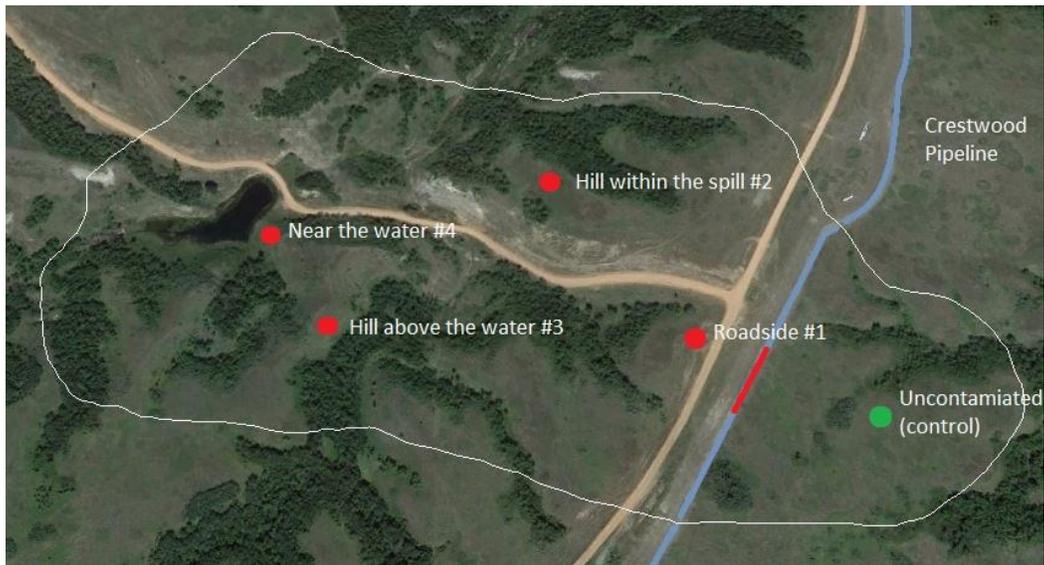
Figure 3. Sample names and location within the study site. Crestwood Pipeline in the blue with the area of pipeline rupture in red.

Field work was conducted on May 24, 2015 in McKenzie County. Soil samples were retrieved from five different locations, one from above the spill site and four within the spill area (Figure 3). Each soil sample was taken 12 inches below the surface, placed in a Ziploc bag and stored in cooler to prevent samples from dehydrating.

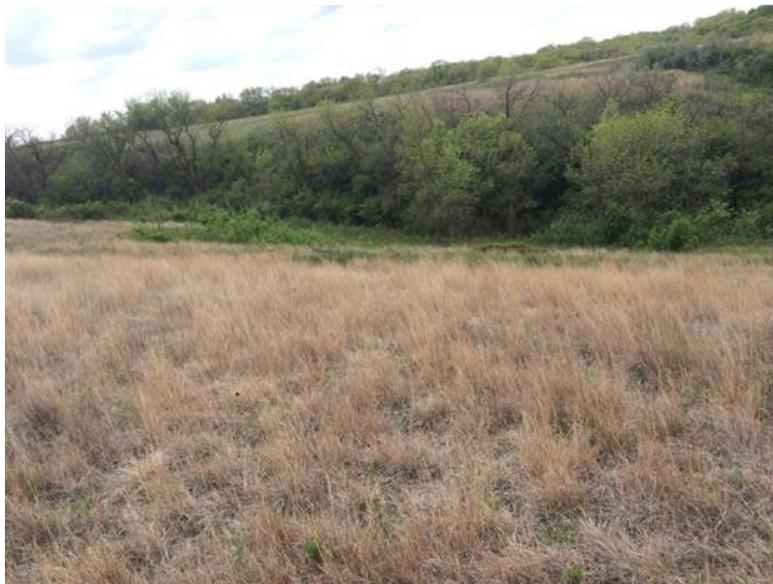
Figure 4. The location from where Roadside sample was retrieved (Photo by: Jeannotte 2015).

As of May 24, 2015, the vegetation of the study site was in poor condition. Some areas within the site had little vegetation, and some areas where the samples were retrieved had dead vegetation as seen in Fig 4-6. Where the water drains into Bear Den Bay, the water seemed to have a film over it; that's where I took sample #4 near the water from (Figure 7).

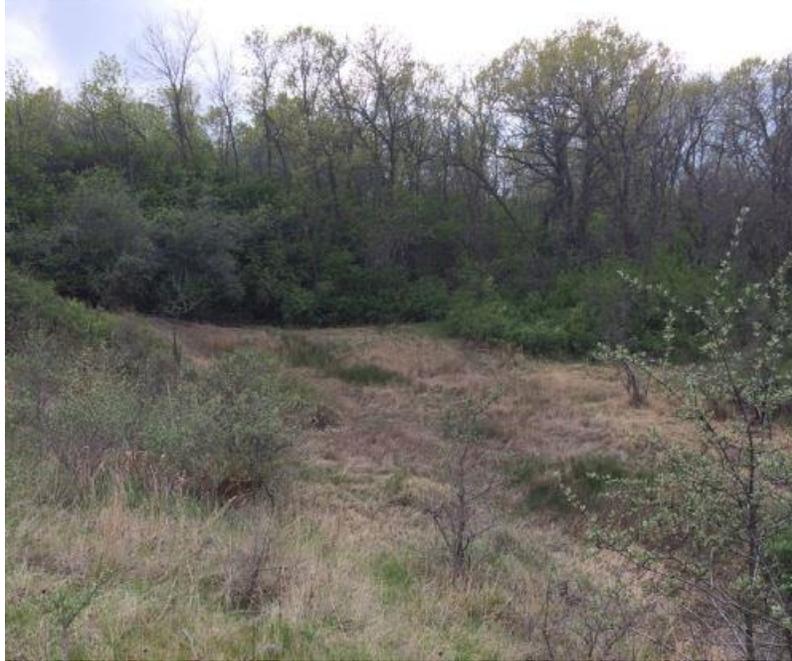
Figure 5. The location from where Hill within the spill sample was retrieved (Photo by: Jeannotte 2015).

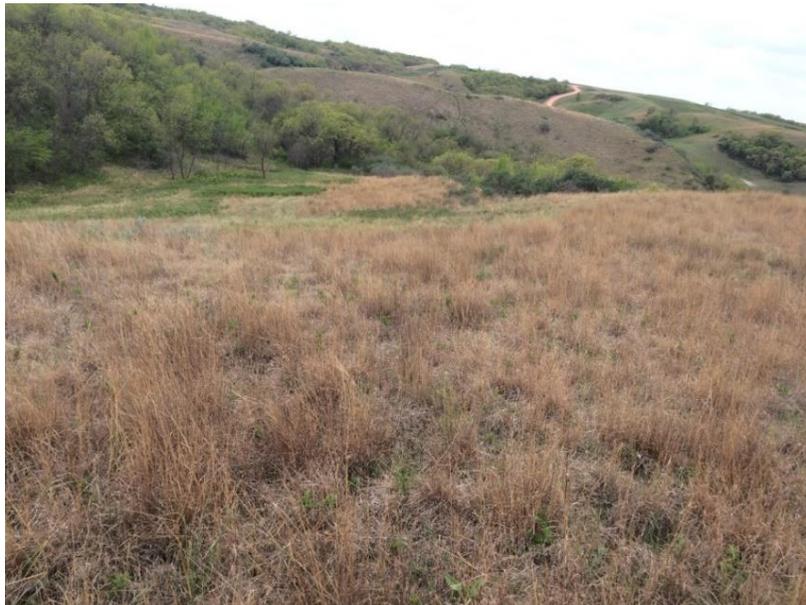
Figure 6. The location where sample Hill above the water was retrieved from (Photo by: Jeannotte 2015)

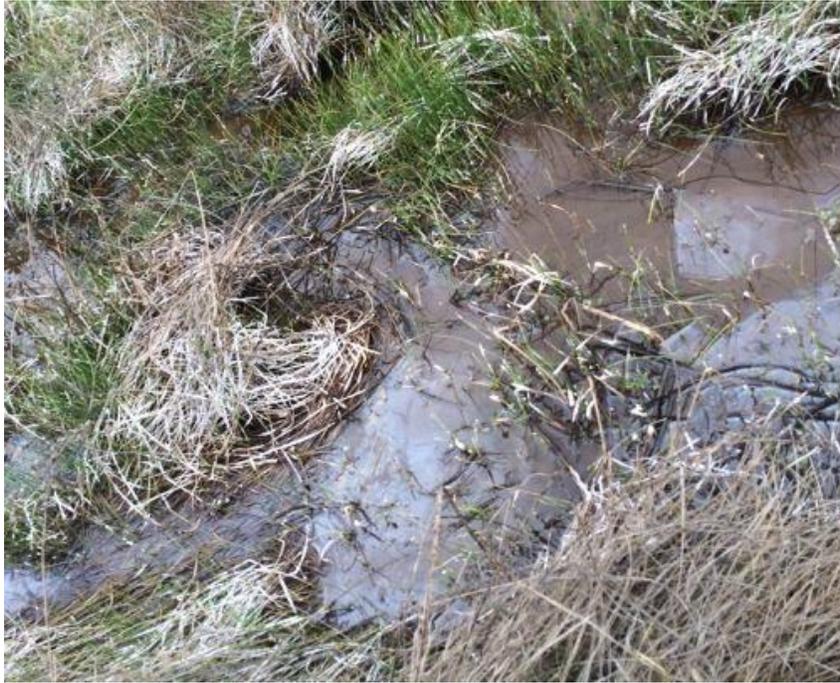
Figure 7. The location from where the near the water sample was retrieved. There was a film over the water in this location (Photo by: Jeannotte 2015).

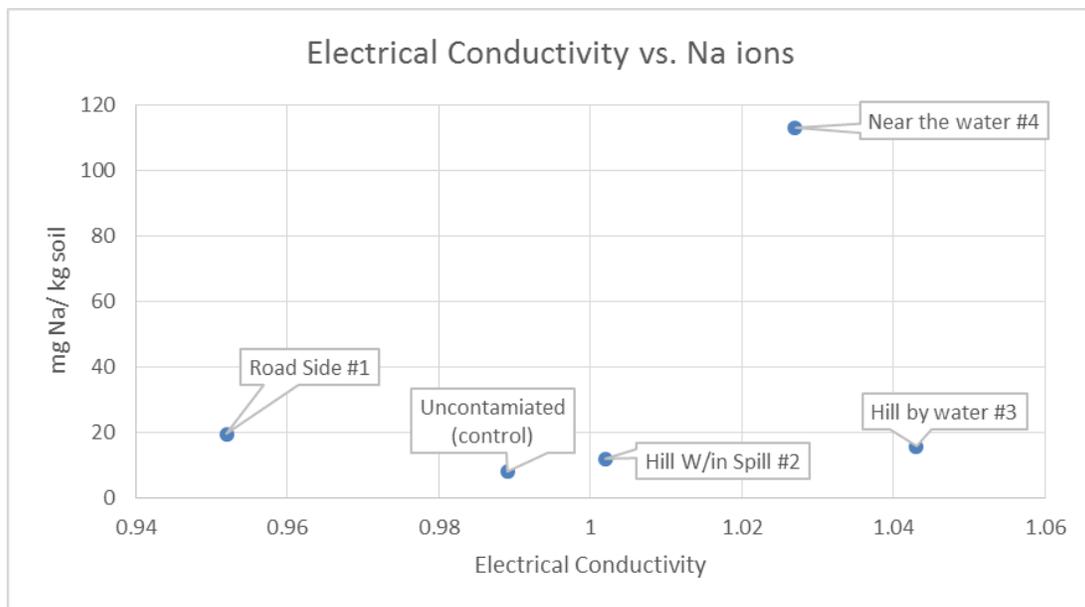
Figure 8. The difference between the Electrical Conductivity and Na ions.

After sending our samples through the AAS we find the different amounts of Na and Ca within our samples. The amount of Na in the samples should correspond with the EC measurements that were taken. Unfortunately, the amount of Na ions don't correspond to EC measurements (Table 4). The reason these values don't correspond is due to the different impurities in the soil that weren't accounted for. Natural impurities within the soils can distort the levels of EC (Gawel, n.d.). The amount of Ca found vary at different amount throughout the site. This might be a result of the different amounts of gypsum that was placed on the site.
